MESQUITE

ENGINEERING REVIEW DRAFT REPORT

OPTIMIZED PAVEMENT RECONSTRUCTION

June 4, 2018

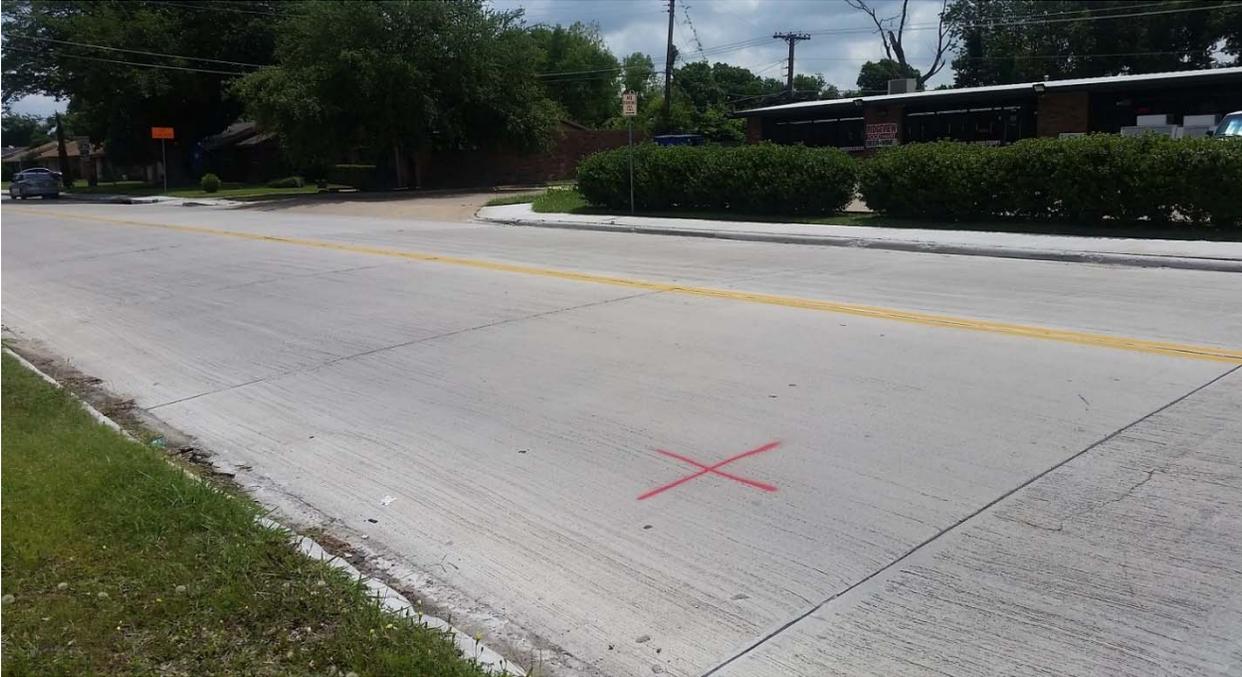
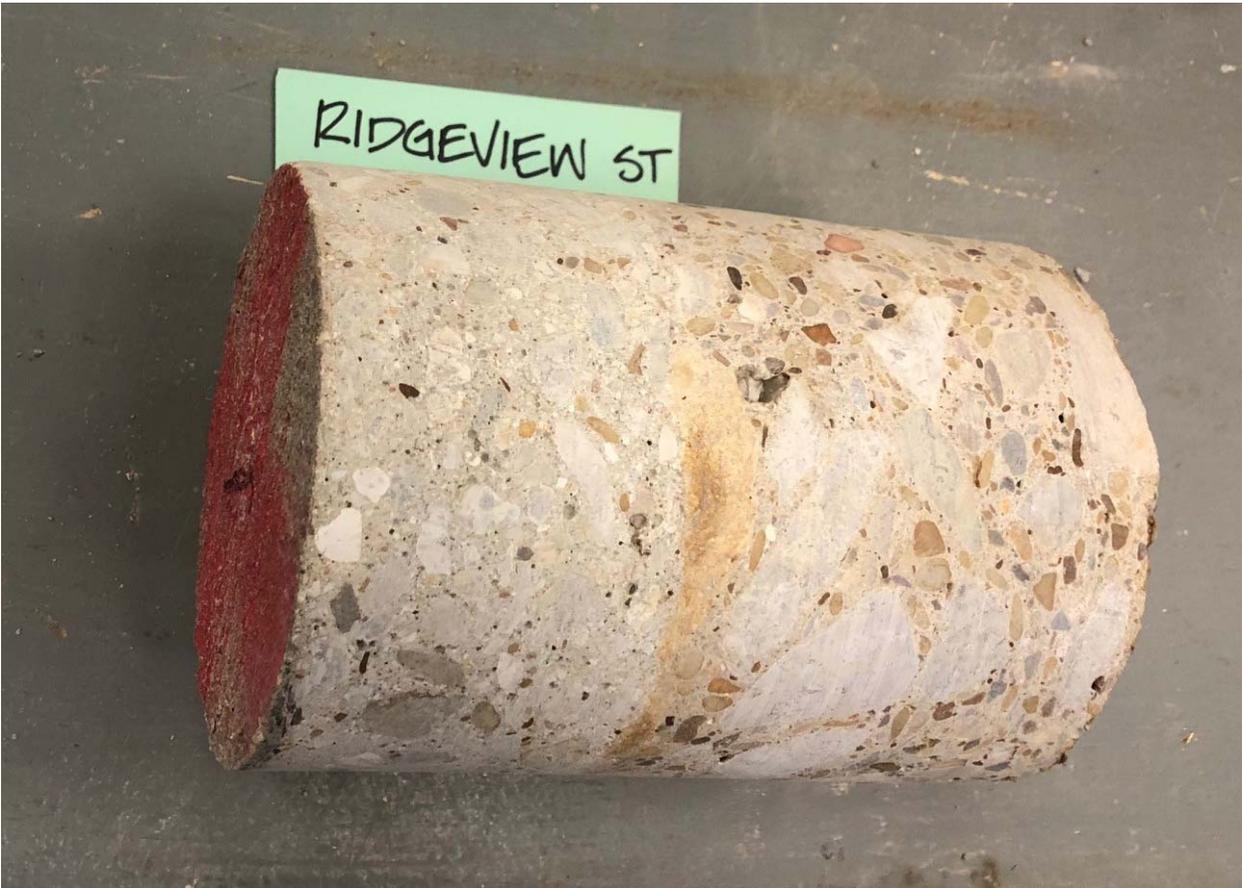
- 1009 Ridgeview Street, SB lane. Confirmed bond in area between transverse cracks.
- 1800 Hillcrest Street, SB lane near east drive to Tisinger Elementary School. Confirmed bond in area of map cracking. Soil sample will be taken to test for moisture content and potential vertical rise (PVR). **Existing pavement appears to contain siliceous river gravel aggregate, which may contribute to debonding due to unequal thermal expansion.**

Confirmed bond in area between transverse cracks.

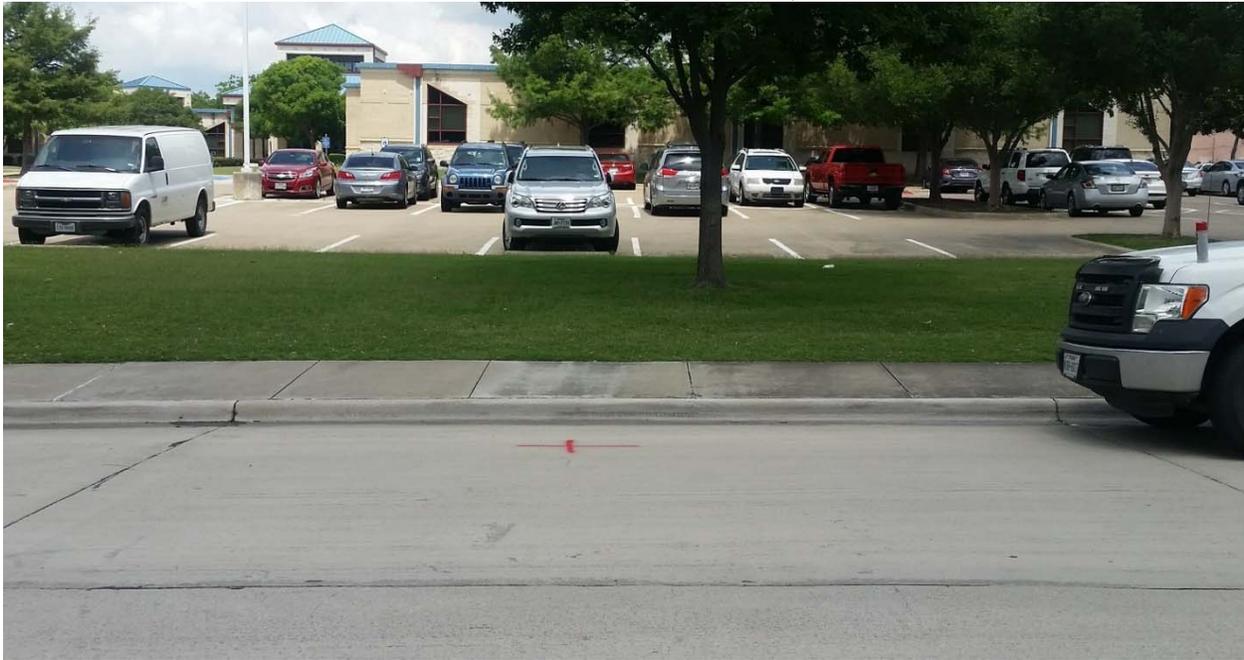
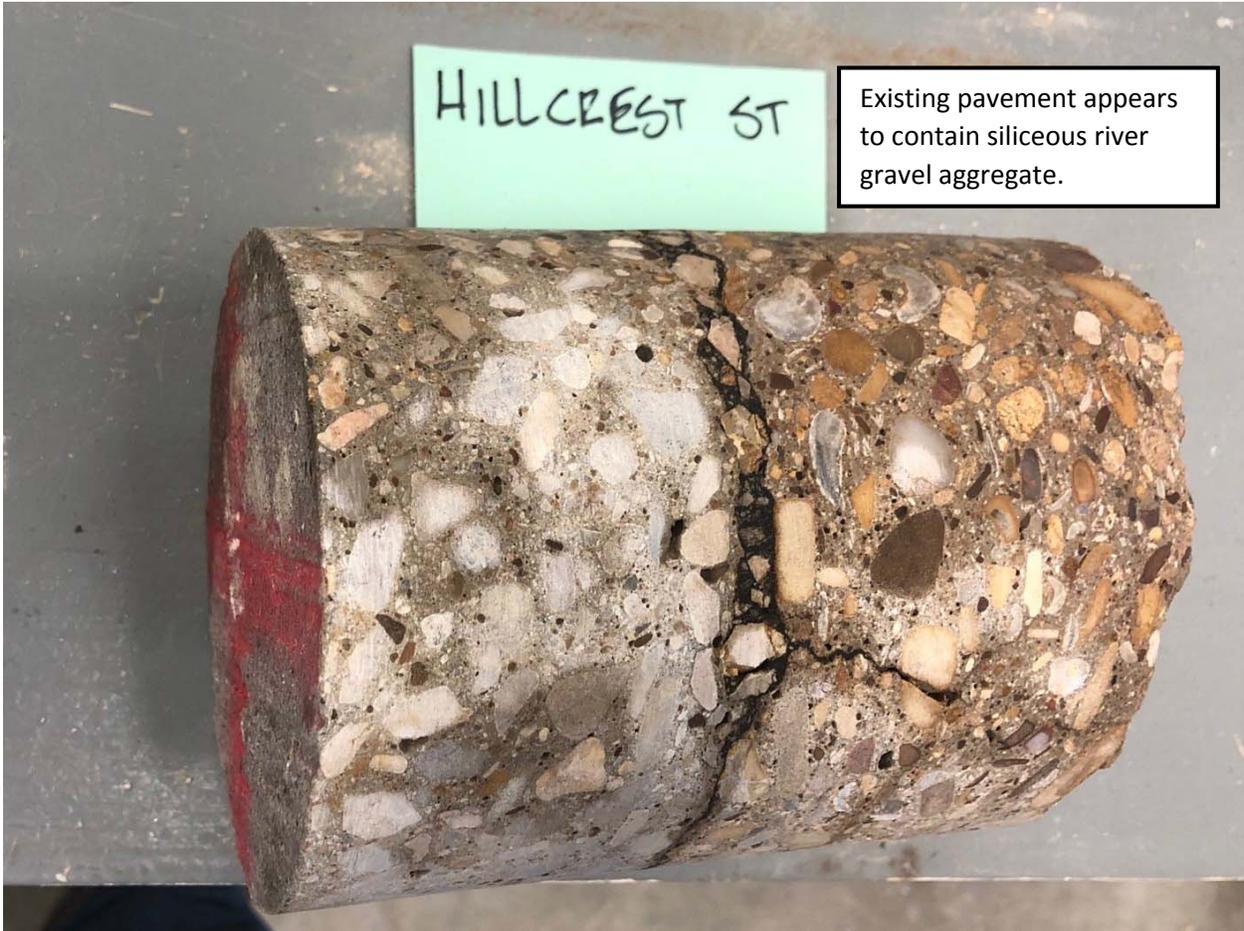
1800 Hillcrest Street, SB lane near east drive to Tisinger Elementary School.

Hillcrest Street in front of Tisinger Elementary School has significant map cracking, indicating possible stress failures or debonding of the overlay. Stains at multiple cracks in the pavement indicate water is pumping from under the pavement. Transverse cracking with water stains and shifting curbs on Northridge Drive at Hillcrest indicate additional subgrade issues. Fixing these problems require repairing leaking water lines. Installation of drain systems to intercept groundwater is not an option, as there is not storm drain system to tie into. A pavement core was taken at 1800 Hillcrest in an area of map cracking in the southbound lane. It showed no

debonding of the overlay despite a ¼" layer of HMAC between the existing pavement and overlay. Due to the evidence of water pumping, a soil sample will be tested for moisture content and potential vertical rise of the subgrade.

Confirmed bond in area of map cracking.

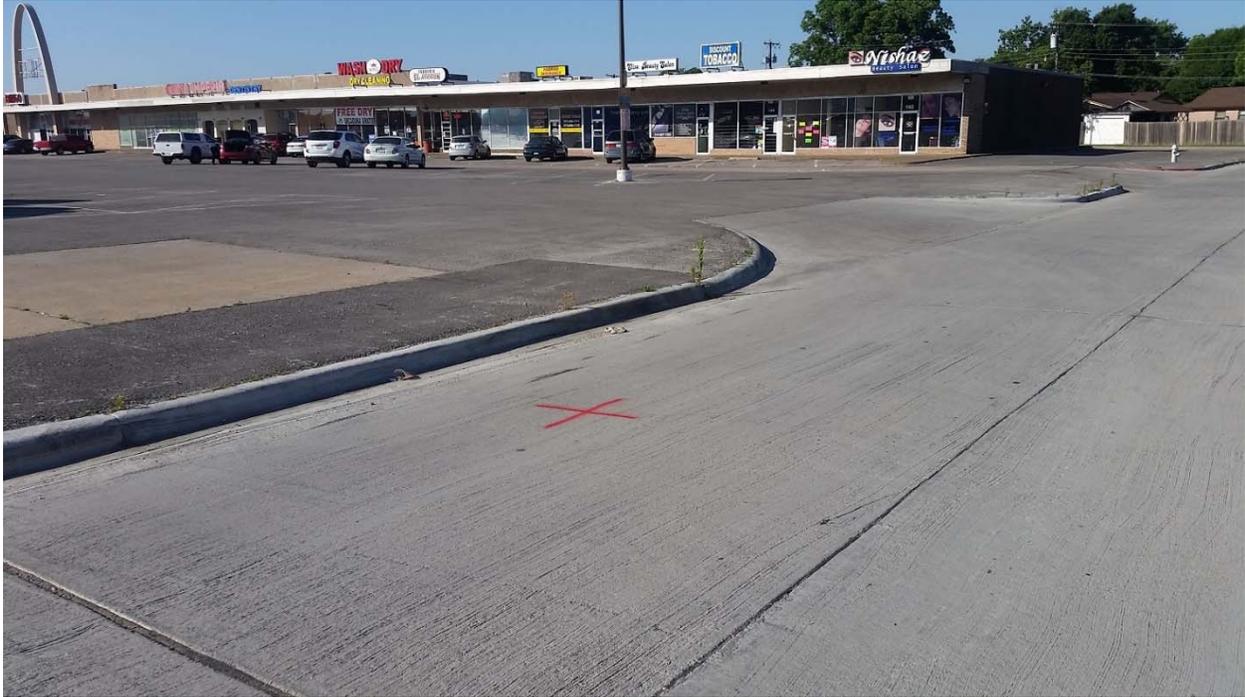
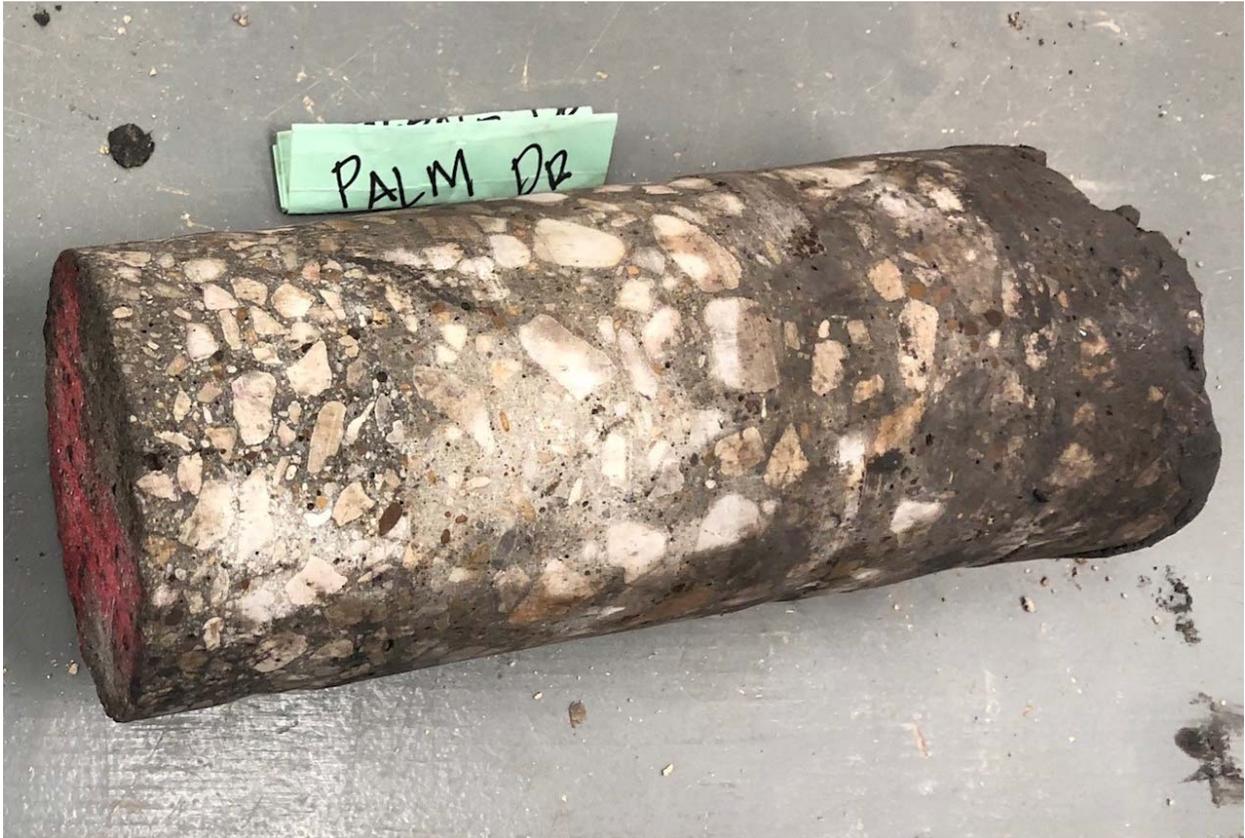
- Palm Drive, SB lane south of Motley, map cracking near curb. Verified bond and demonstrated 11" existing pavement depth. Soil sample will be taken to test for moisture content and PVR.

Verified bond and demonstrated 8.5" existing pavement depth.

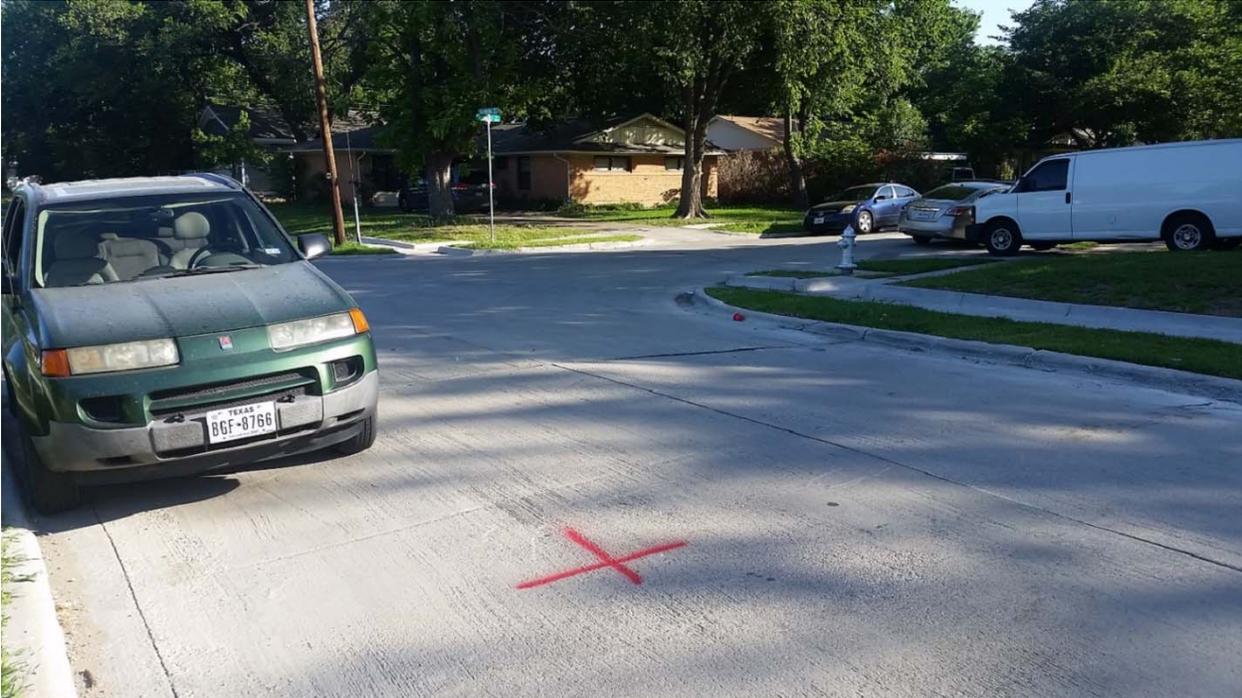
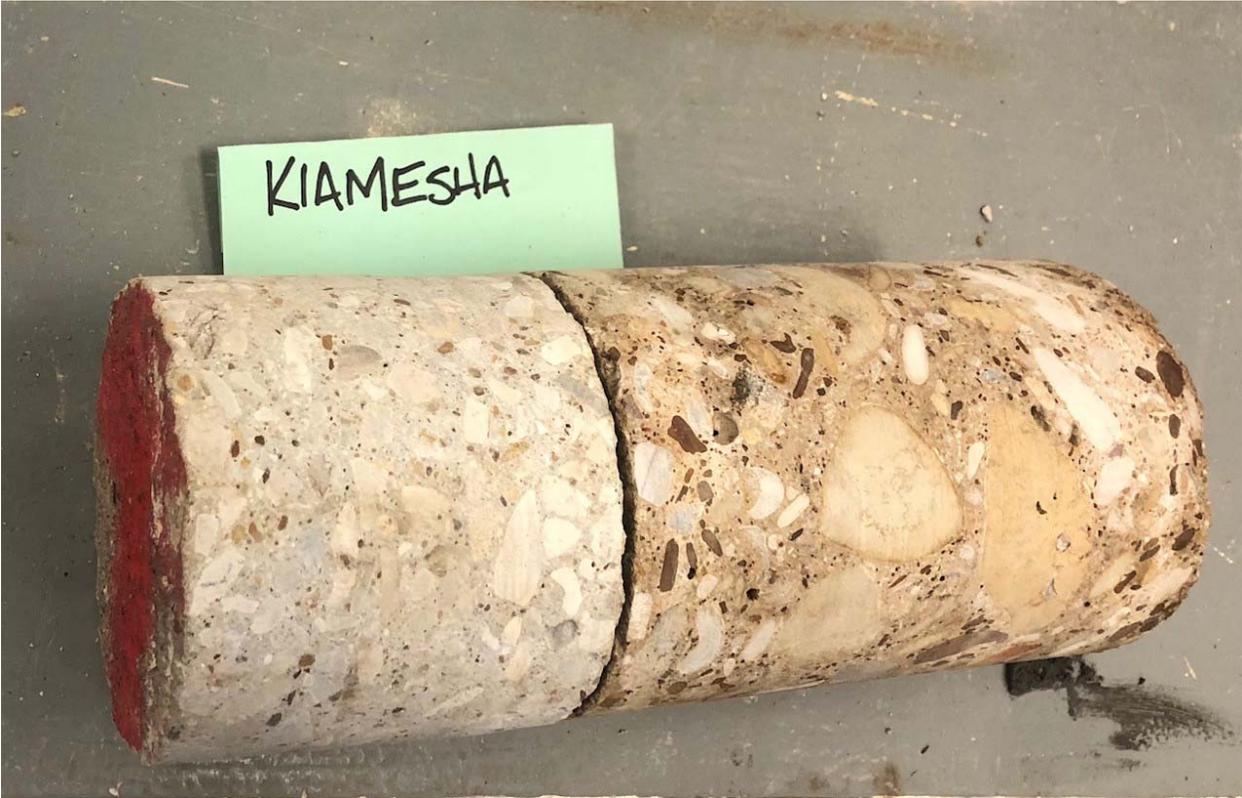
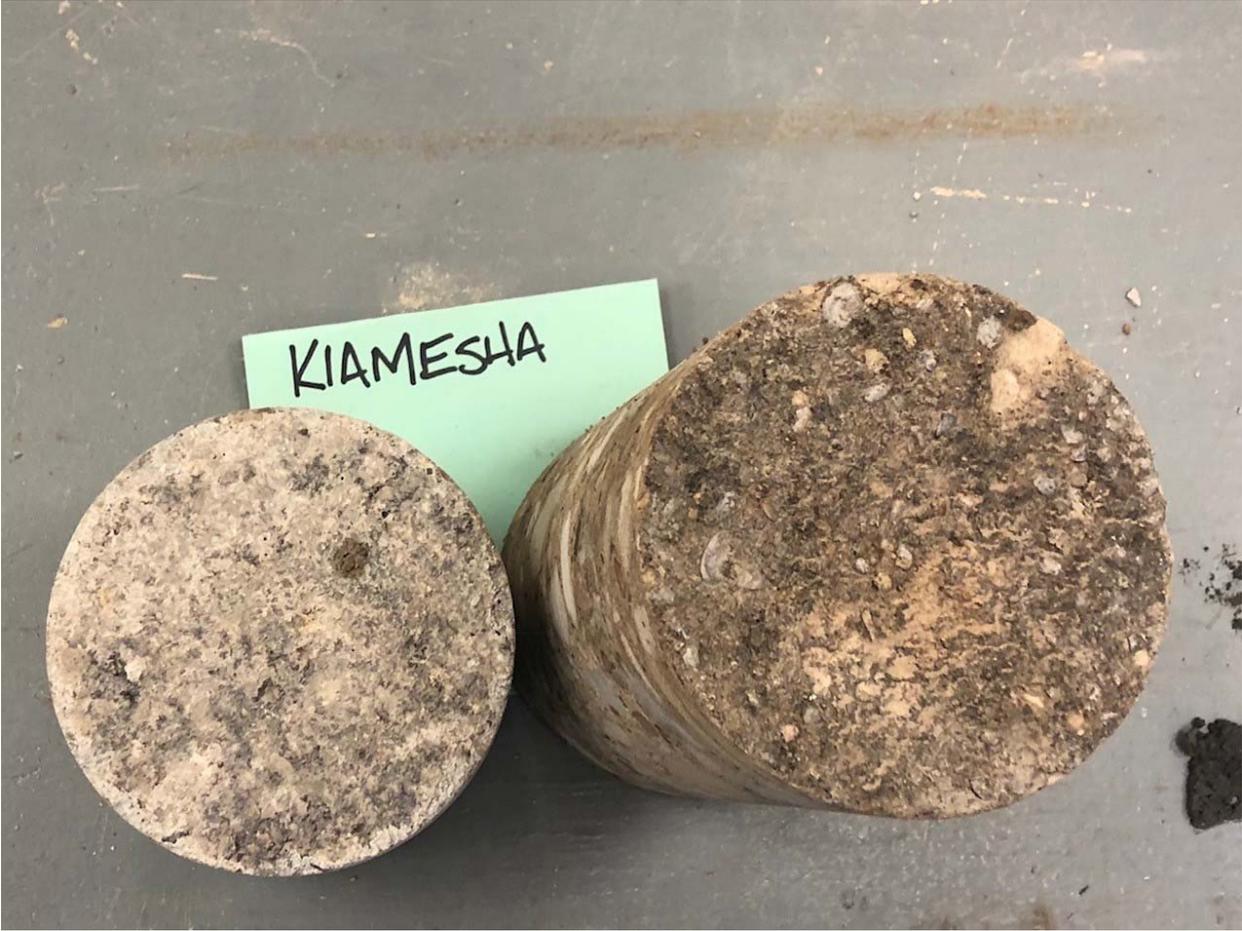
North of La Prada there are small areas with transverse and map cracking, including Kiamesha Way at Nabholtz Lane. A pavement core taken here was debonded, and showed a thin layer of HMAC between the existing pavement and overlay. There was a leaking water line at the intersection of Kiamesha and Tam O Shanter, but the pavement in this area didn't show significant distress. Overall the streets north of La Prada appear in good condition.

- 5115 Kiamesha at Nabholtz intersection. Core showed loss of bond in area of block cracking. **A thin layer of HMAC between pavement and overlay may be causing map cracking and loss of bond.**

Core showed loss of bond in area of block cracking.

Thin layer of HMAC between pavement and overlay may be causing map cracking in this area.

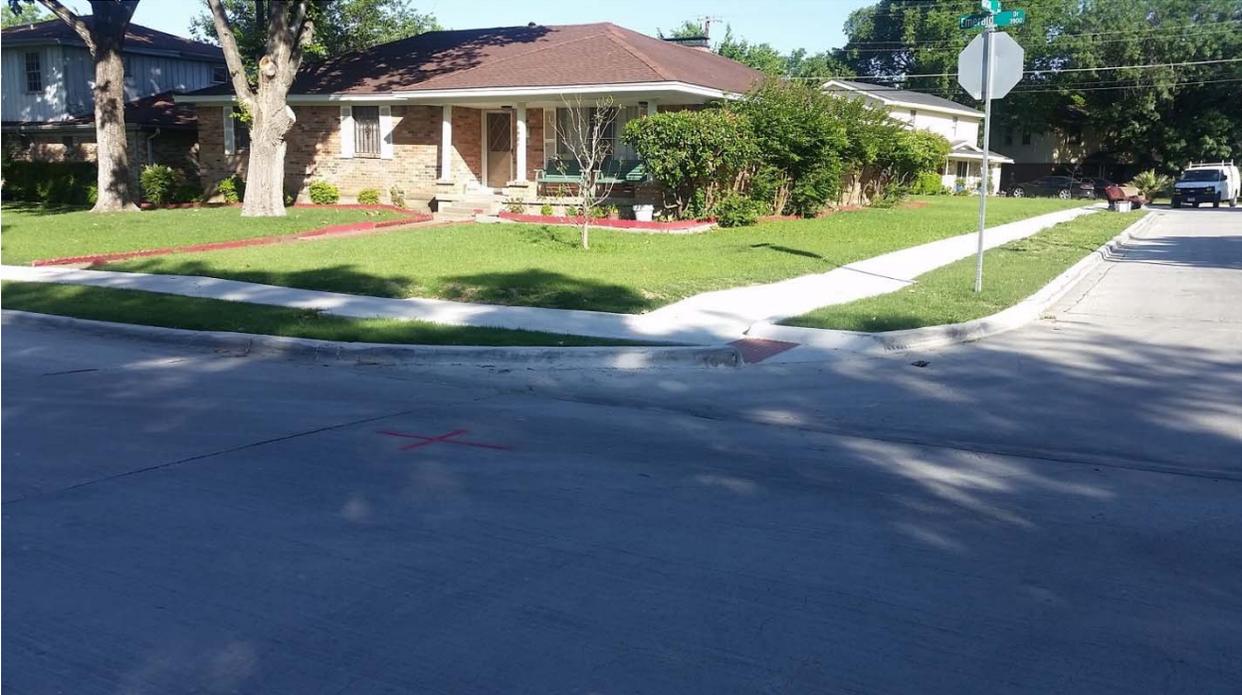
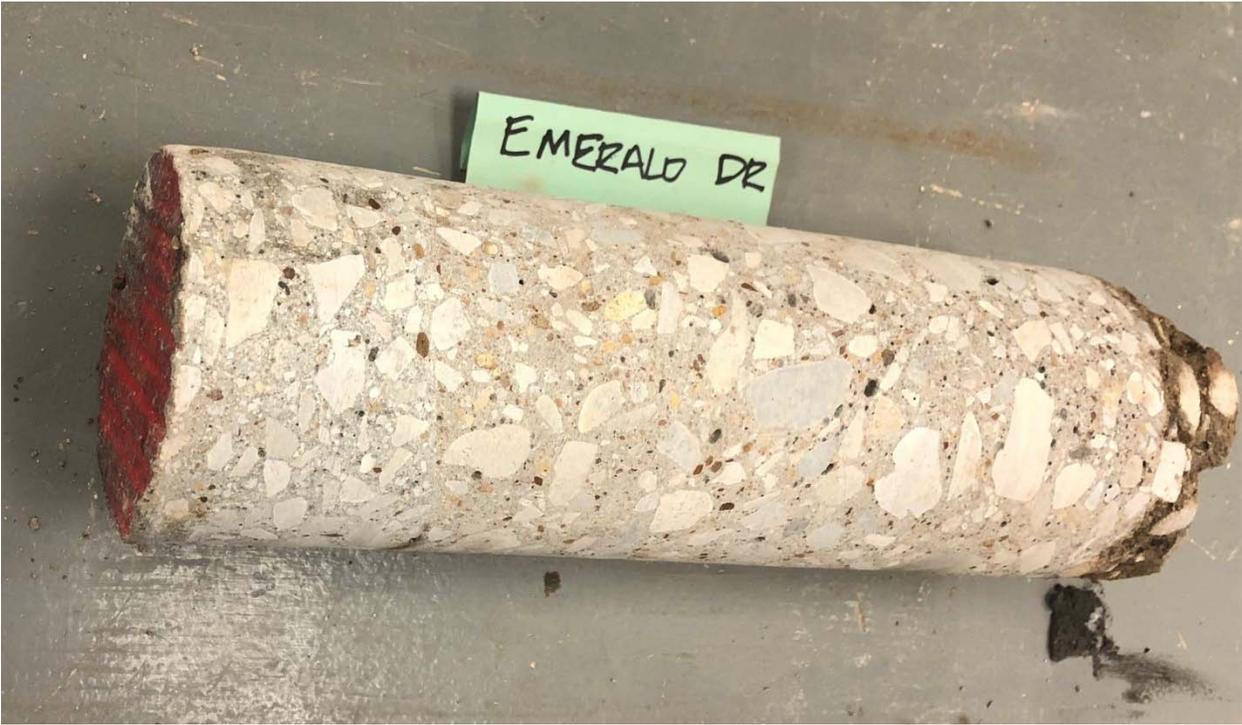
- 3901 Emerald Drive, SB lane. Verified bond in area of shrinkage cracking.

Verified bond in area of shrinkage cracking.

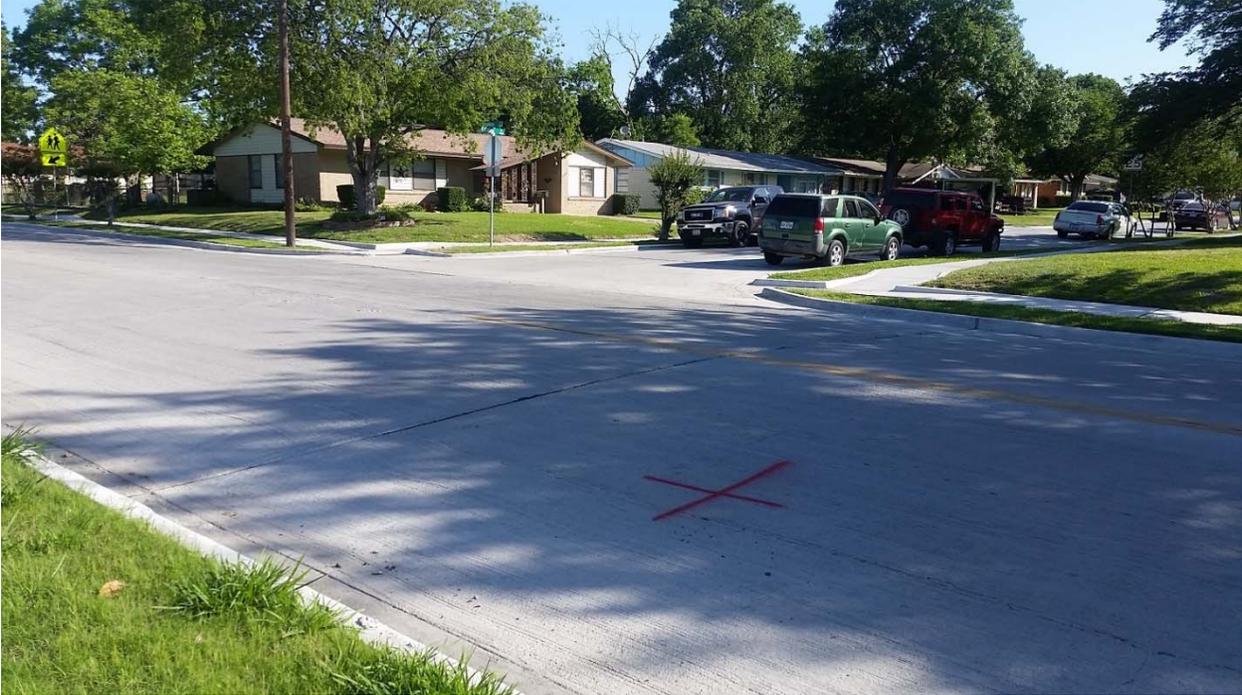
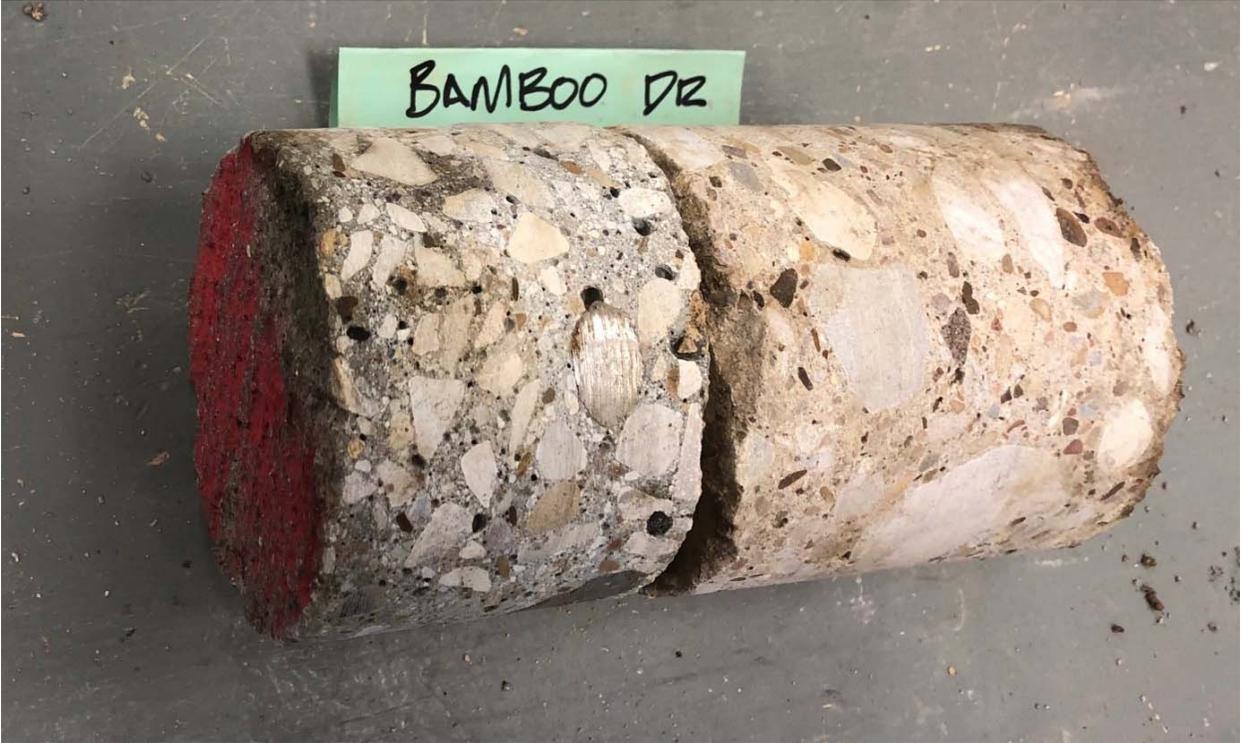
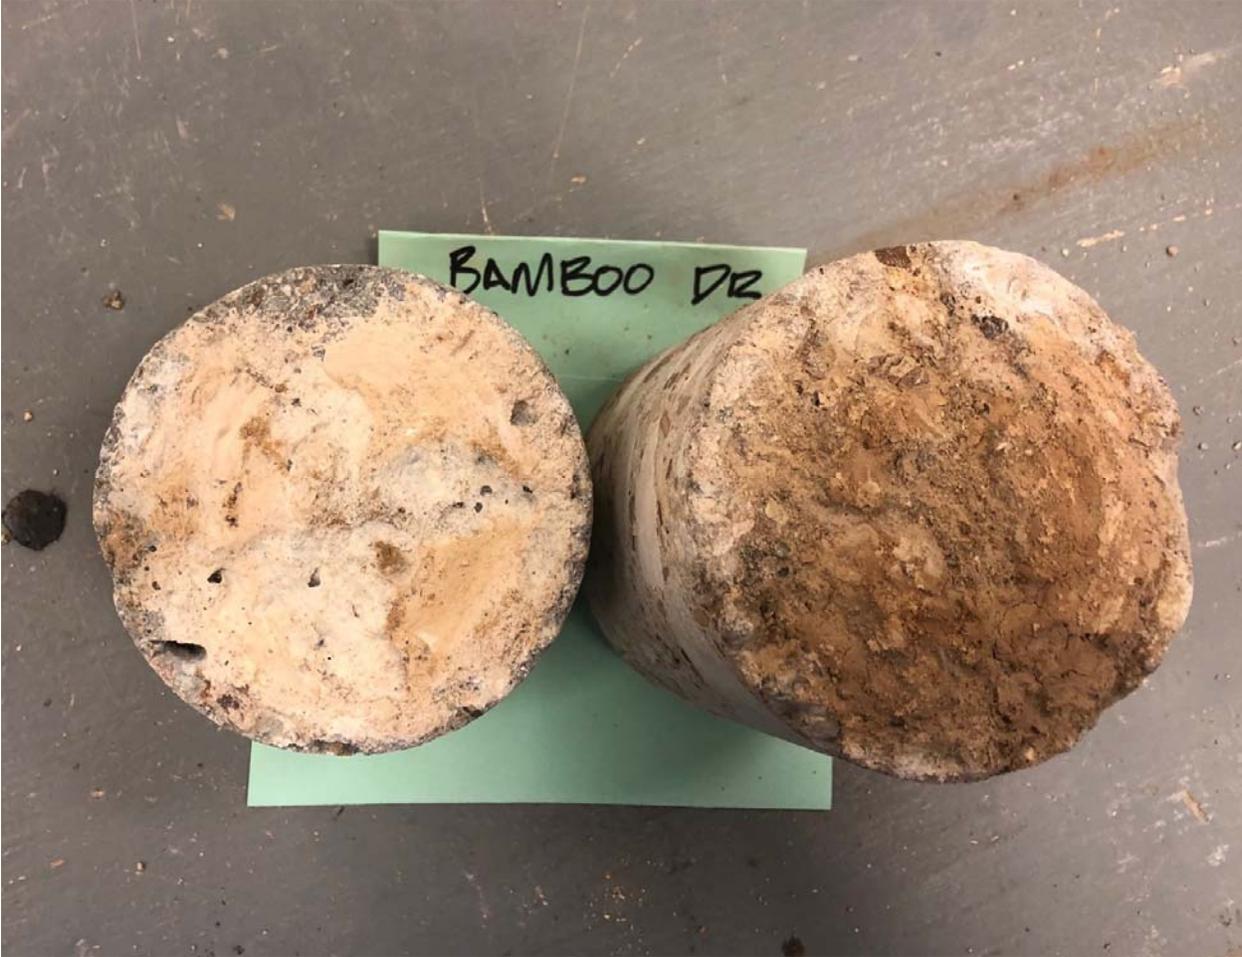
Bamboo Street has been overlaid between Emerald and Bahamas Drives, a two block section in front of Range Elementary School. Being at a school, this section carries more passenger traffic but also heavy vehicles (school busses, delivery and industrial garbage trucks). Heavy vehicles cause more damage to pavement than passenger vehicles, so this may be impacting the condition of the pavement. A walking examination shows extensive transverse and map cracking. It appears the overlay has debonded, and has a high likelihood of failing. A pavement core taken at the Catalina intersection showed debonding with silt between the concrete layers. Photographs or video taken before the overlay should be reviewed for weak areas in the pavement, but it is unlikely city inspectors would have allowed the overlay to progress if the existing pavement showed large scale failures. A review of inspection records is in order.

- 300 Mockingbird, NB lane. Verified bond in area of shrinkage cracks.
- Bamboo Drive at Catalina, EB lane in map cracking. **Debonding with significant silt/clay residue between layers was noted on core sample.**

Debonding with significant silt/clay residue between layers.

Unclear whether this is a cause or result of the debonding.

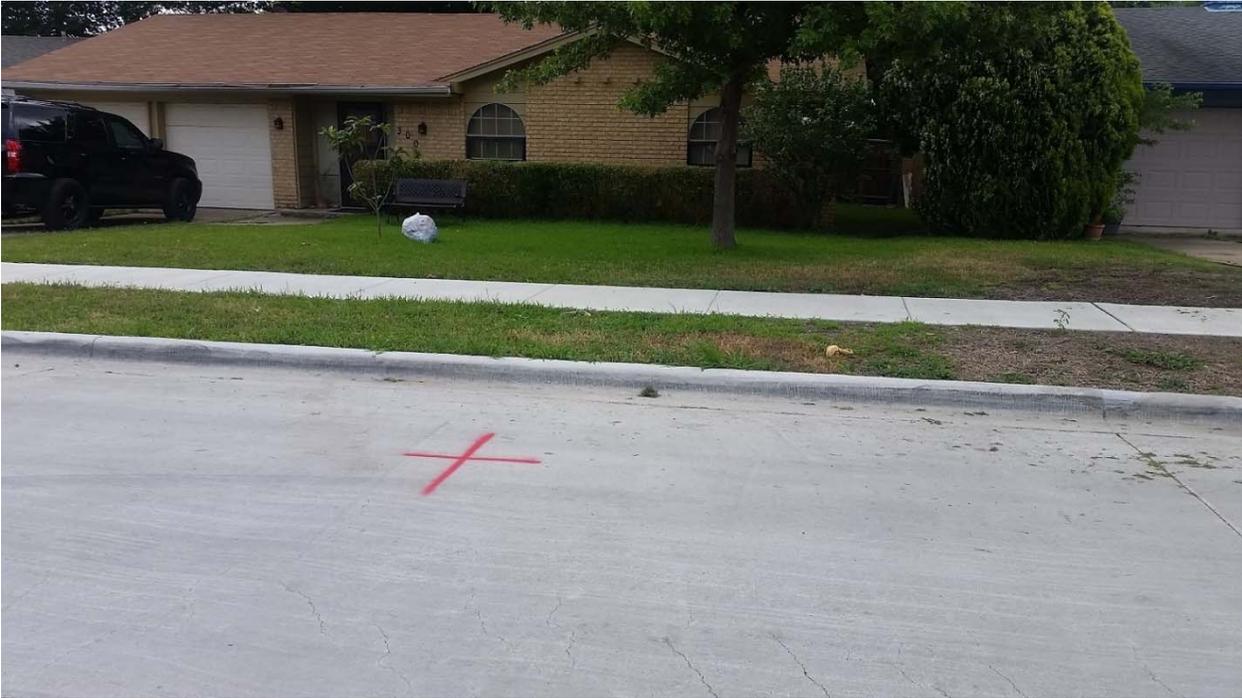
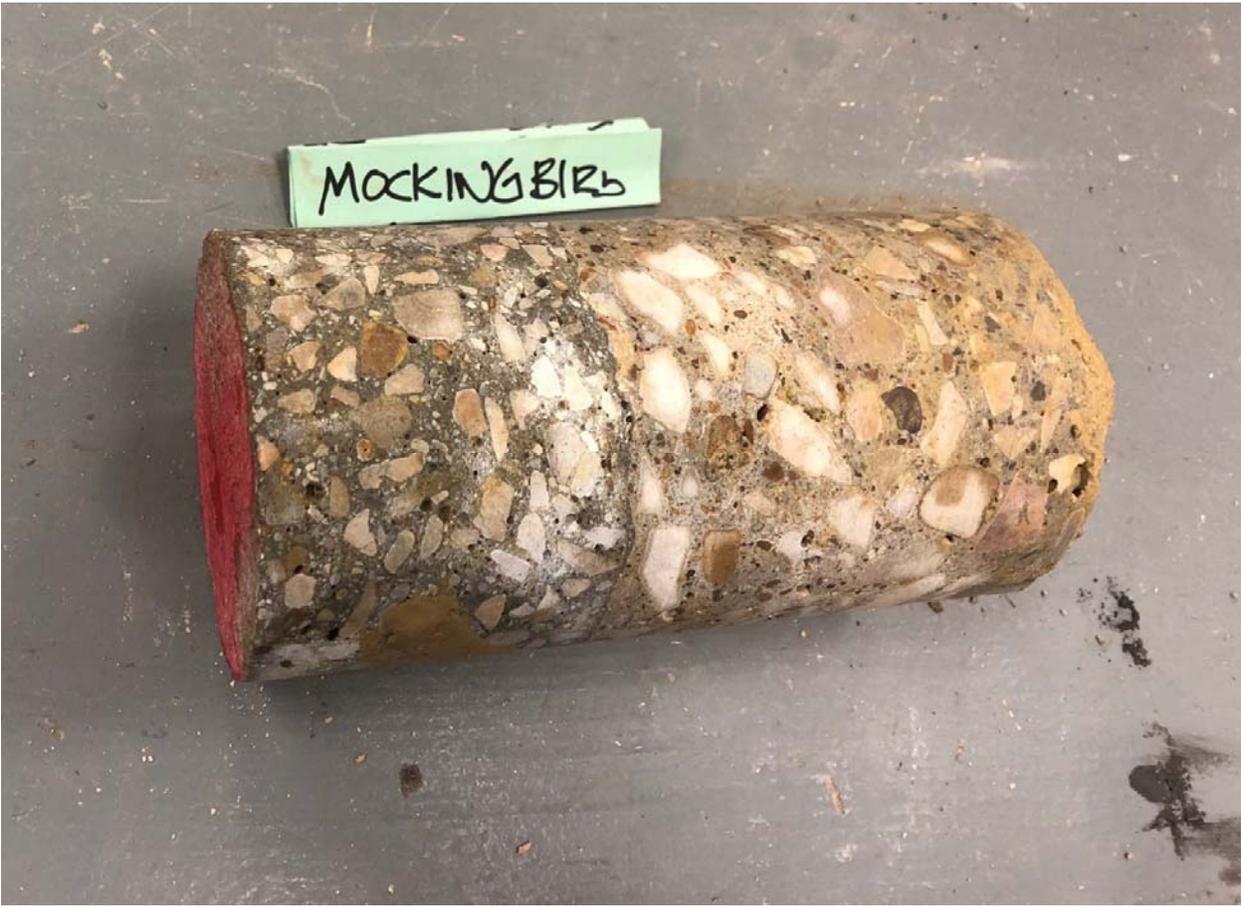
300 Mockingbird, NB lane.

locations. A review of construction inspection records for these streets might indicate a reason for the cracking (high temperatures, low humidity, windy, high concrete slump). A pavement core taken at 300 Mockingbird in an area of shrinkage cracking was fully bonded.

Verified bond in area of shrinkage cracks.
