MESQUITE

ENGINEERING REVIEW DRAFT REPORT

OPTIMIZED PAVEMENT RECONSTRUCTION

June 4, 2018

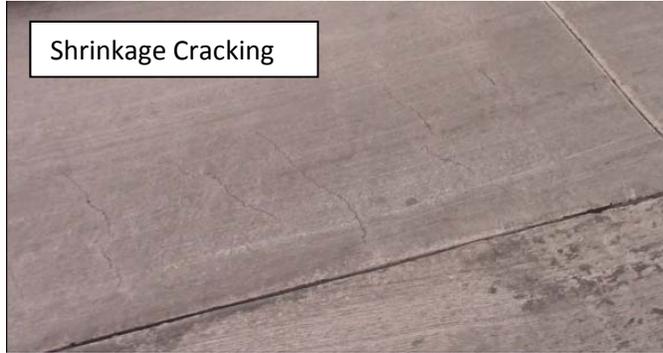
Plastic shrinkage cracking appears soon after concrete is placed, and indicates the surface of

the concrete was not protected from heat or wind during placing and curing, or there were significant changes in the temperature of the concrete during the first 24 hours after placement. One form of PSC results from excess bleed water in the concrete, which causes very small cracks or “crazing” of the surface paste, which is typically shallow and of little

concern. As plastic shrinkage cracking is typically due to an environmental or material factor on a given day, it often occurs in multiple locations over the full area poured that day, or in multiple pours made from the same batch of concrete.

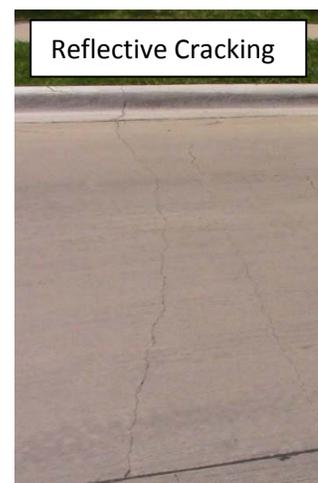
Reflective cracking is usually transverse cracks that mirror cracks in the existing pavement. Some appear soon after placement, with more typically appearing as the existing pavement flexes under traffic due to uneven subgrade support, eventually breaking through the overlay. OPR overlays offer some resistance to reflective cracking as the additional steel layer contributes to containing cracks rather than relying on just the concrete strength.

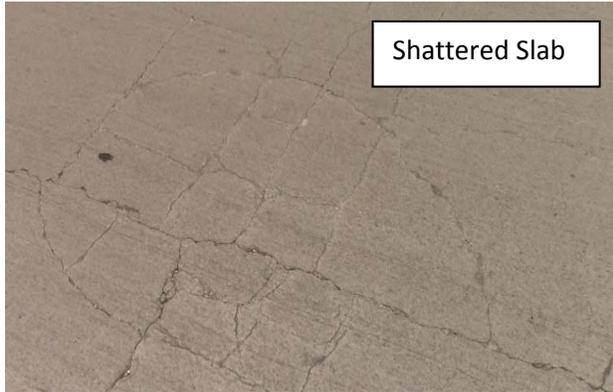
Shattered slabs are the result of repeated loads on an area with poor subgrade support,

resulting in closely spaced cracking of the pavement. Areas prone to shattered slabs should show existing cracking prior to overlay, indicating the need for full depth repairs before the overlay is placed. However they are commonly addressed in existing pavements by HMAC patches. These patches often mask the location of weak support until the patch is milled off, and they can be difficult to spot on a milled surface.

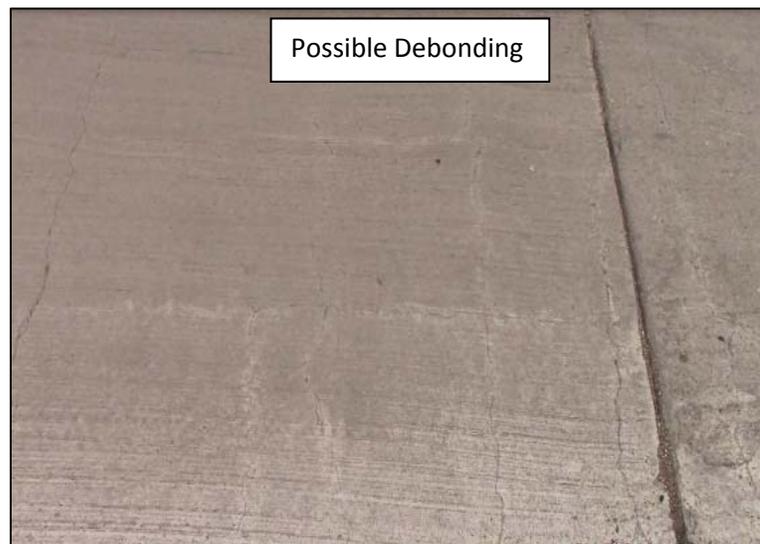
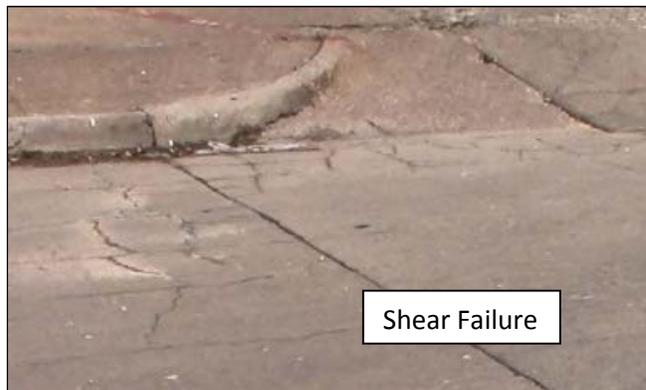
Debonding typically shows as block or map cracking similar to stress cracking, but may occur in areas with no noticeable cracking in the existing pavement. All cracking of the overlay can lead to debonding due to water infiltration to the interface between pavement and overlay.

Shear failures result from heavy loads inducing high stresses that exceed the capability of the composite pavement structure to support. Typical shear failures result from overweight or non-typical loads, such as garbage trucks or transit mix concrete trucks serving maintenance or construction activities. The culprit is difficult to identify because initial fractures to the concrete are invisible to the naked

eye, but grow over time with repeated traffic loading and as surface water infiltrates the pavement and deteriorates the concrete.

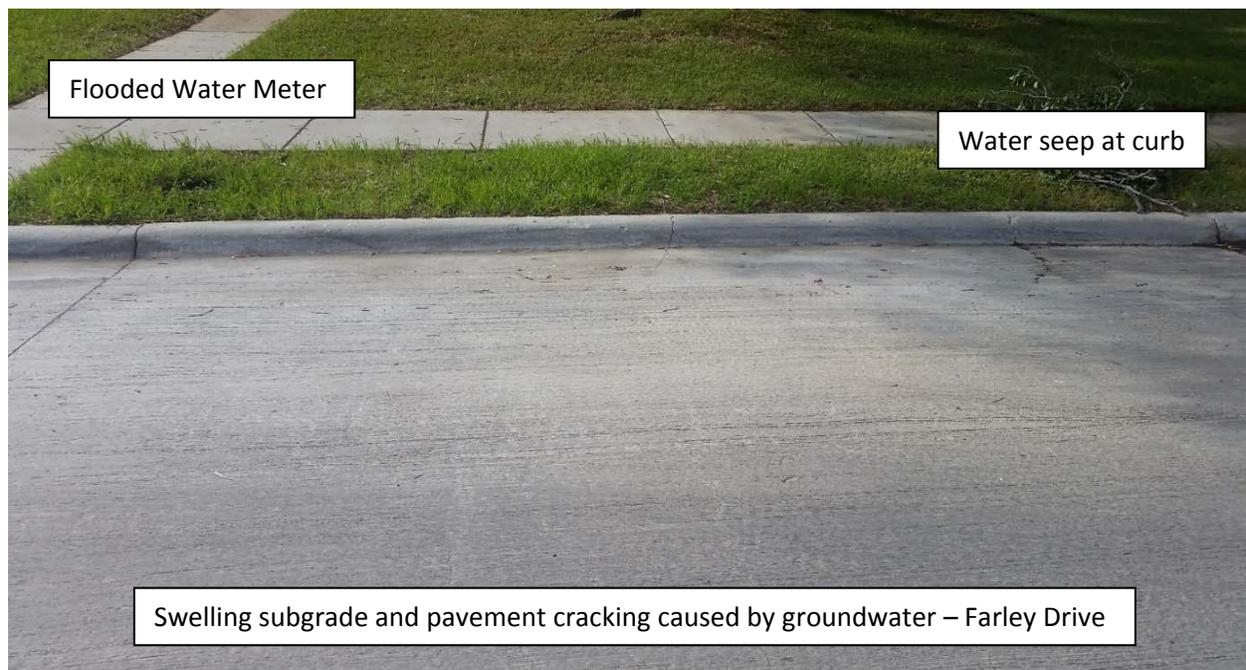
Rain is the most obvious source of water problems, but more damage is typically caused by **ground water**, often from leaking water lines and meter connections to service lines. Poor

drainage and excessive landscape irrigation also saturate soils. Large trees with roots extending to the pavement can impact the street by physically lifting the pavement through root growth, but more commonly the roots draw groundwater out of the soil in spring and summer and allow it to return in fall and winter, creating an annual shrink/swell issue. Long term pavement stability is enhanced when city staff identify water leaks and other problems as part of regular meter reading, and address them before water causes permanent damage to pavements.
